NASA Technical Memorandum 81252

**NASA Aviation Safety  
Reporting System:  
Quarterly Report No. 12**

December 1980

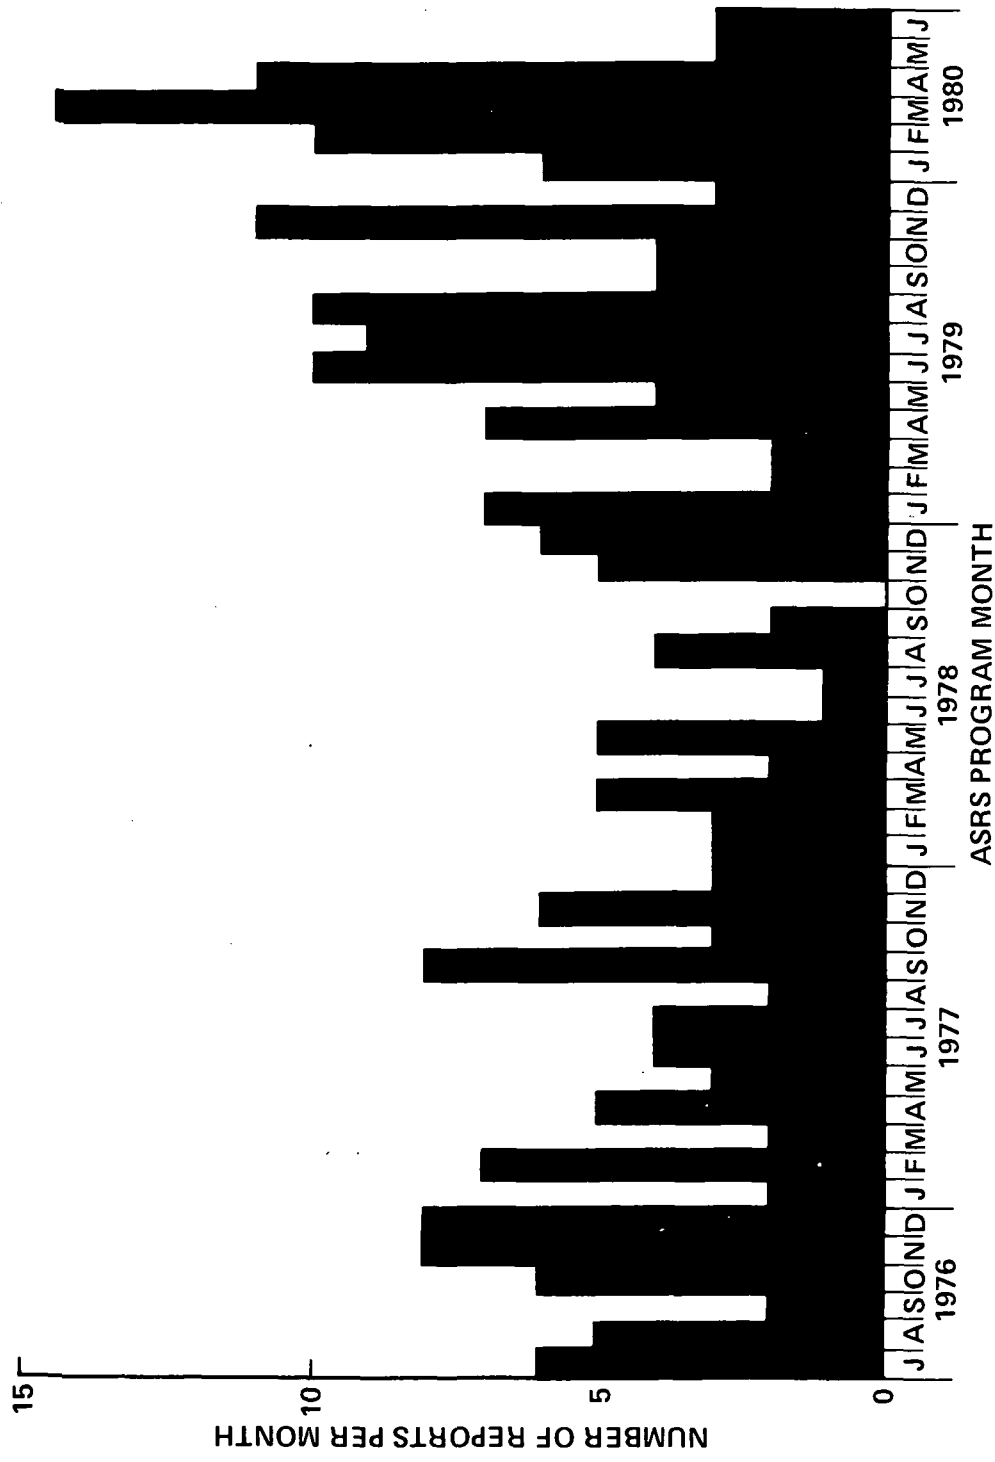
Figure 1.— Monthly receipts of ASRS reports associated with briefing of relief.

Figure 1 shows the number of ASRS reports, received since July, 1976, that were associated with the briefing of controller reliefs. There was a gradual decrease in reports until October 1978, the only month during which no reports were received. Since that time the number of these reports has tended to increase slightly, but this is not considered to be statistically significant since these reports comprise less than 1% of the total database. The increase may be attributable to recent changes in the immunity feature of the ASRS program, which fostered multiple reporting of the same occurrence.

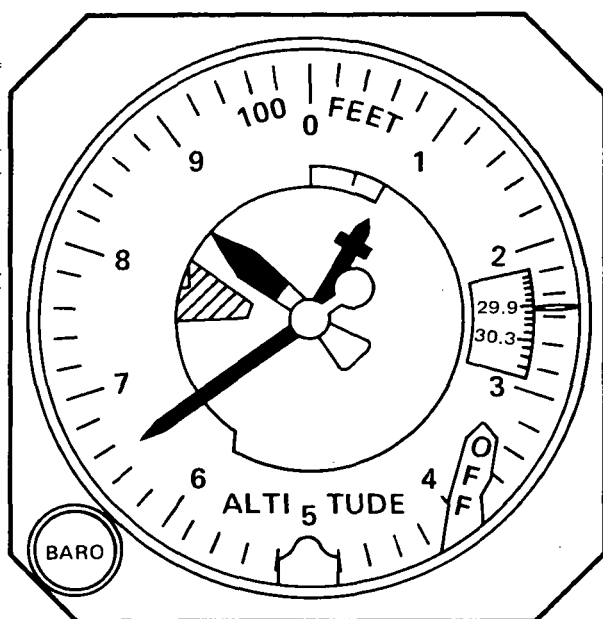
Figure 1.— Three-pointer altimeter.

A typical "three-pointer altimeter" is shown in figure 1. The three progressively shorter needles denote altitude in 100-, 1,000-, and 10,000-ft intervals, respectively. Each complete revolution of the 100-ft pointer indicates a change in altitude of 1,000 ft, as indicated by the 1,000-ft pointer. The shortest 10,000-ft needle is incremented one unit with each complete revolution of the 1,000-ft pointer.

Kollsman windows appear on all four instruments and display barometric pressure reference settings in either millibars or inches of mercury or both. Adjustments are made by means of the small knob on the front of the instrument cases.

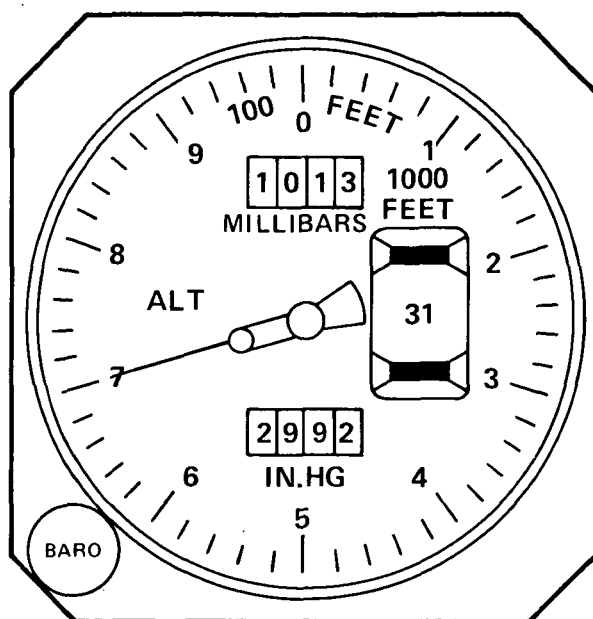
Figure 2.— Drum-pointer altimeter.

A "drum-pointer-type altimeter" is shown in figure 2. To the right of center of this instrument is a window containing two rotating counters which indicate feet in units of thousands and ten-thousands. Each complete revolution of the single pointer increments altitude by 1,000 ft. Whenever the aircraft is below 10,000 ft, a yoke flag appears over the innermost counter.

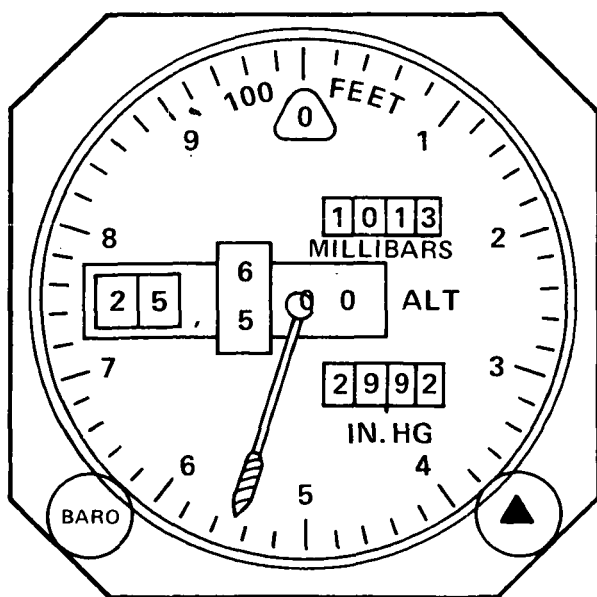
Figure 3.— Counter-drum-pointer altimeter.

Typical "counter-drum-pointer and counter altimeters" are illustrated in figures 3 and 4. Precise altitude tracking is maintained by means of the single pointer; a five-place numeric readout is available on the dial face for quick altitude reference. The basic design of these two instruments is similar, except that newer counter-pointer altimeters employ a snap-type action to rotate the digits; the counter-drum-pointer retains an analog motion with an expanded hundreds window to permit correct interpolation to the nearest hundreds place.

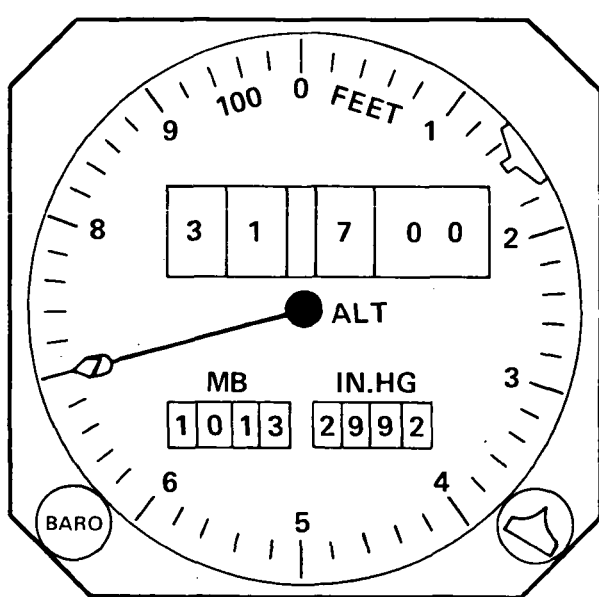
Figure 4.— Counter-pointer altimeter.
